Condenser Tube Failure

– A technical update –

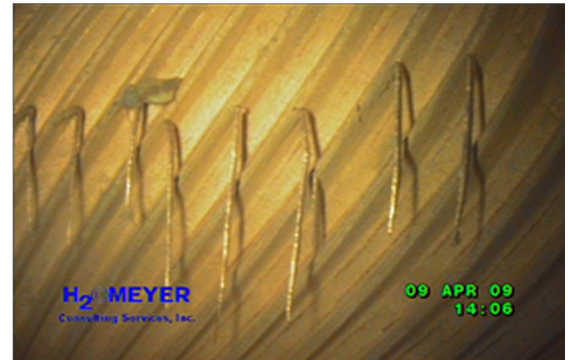
Figure 1:

Row 30, Tube 41 – Manufacture defects of tube enhancements

When a chiller is re-tubed or a new machine is installed, it is our commendation that the tubes be cleaned, passivated, and visually borescoped to establish a baseline condition of the tube surfaces. The borescope should have the capabilities to take pictures at a 90 degree angle in order to detect defects or reveal corrosion on the tube surfaces prior to putting the machine in service.

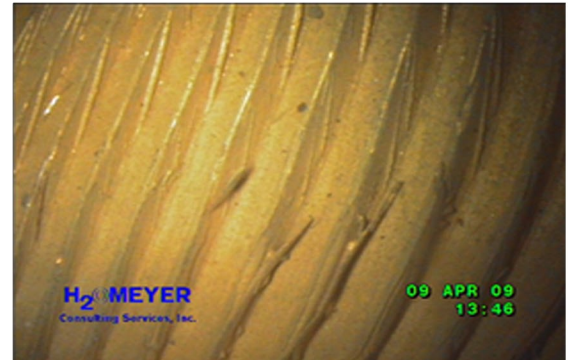
Figure 2:

Row 15, Tube 24 – Manufacture defects of the tube enhancements

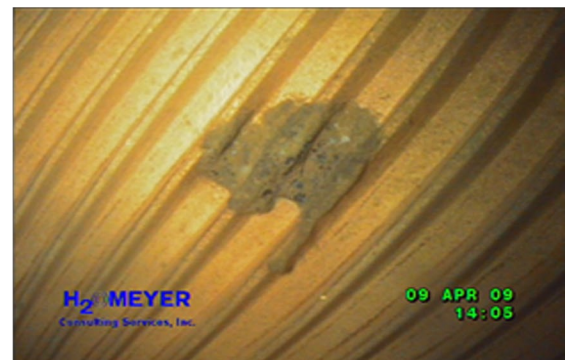
Figure 3:

Row 30, Tube 41 – Visible corrosion
